Situation Photo Log

Thursday, November 8, 2012

Kalamazoo River / Enbridge Spill

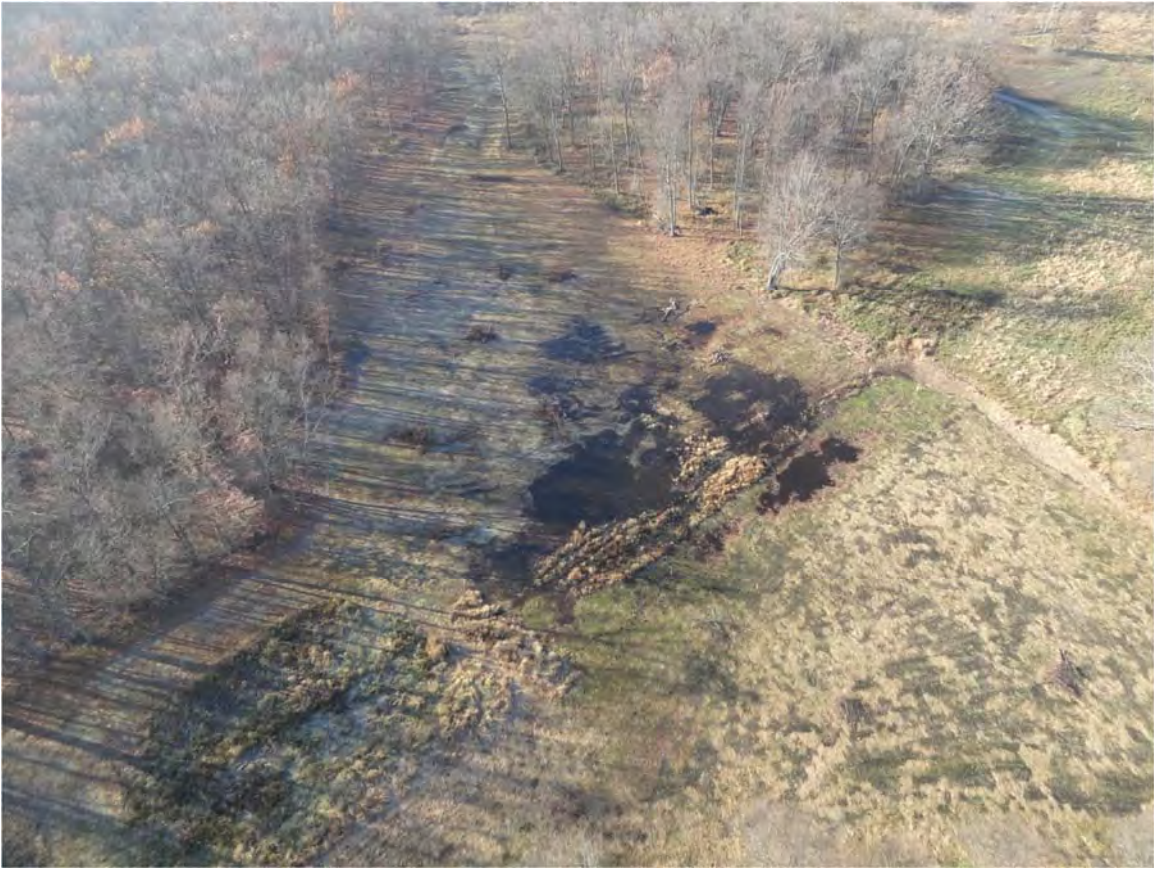
1. Source area, no sheen observed.

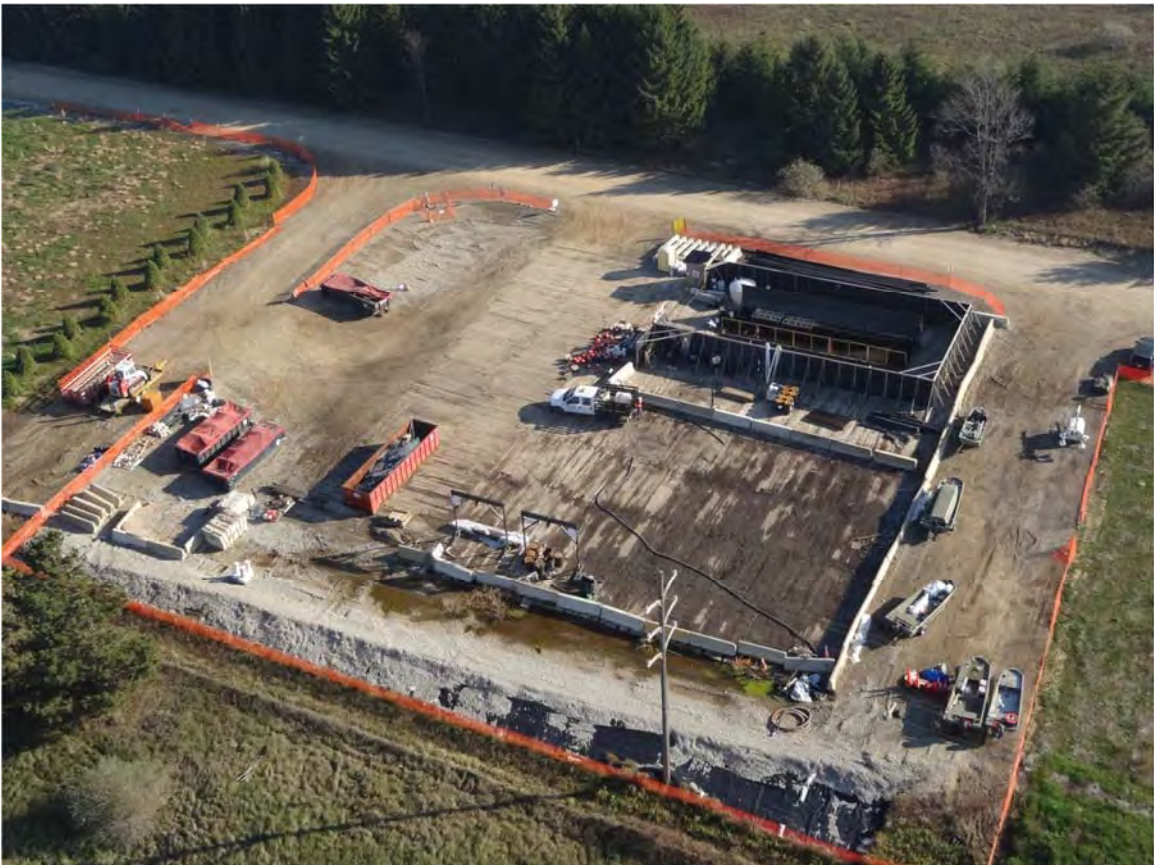
2. Frac-Tank City, observed a truck dewatering the pad.

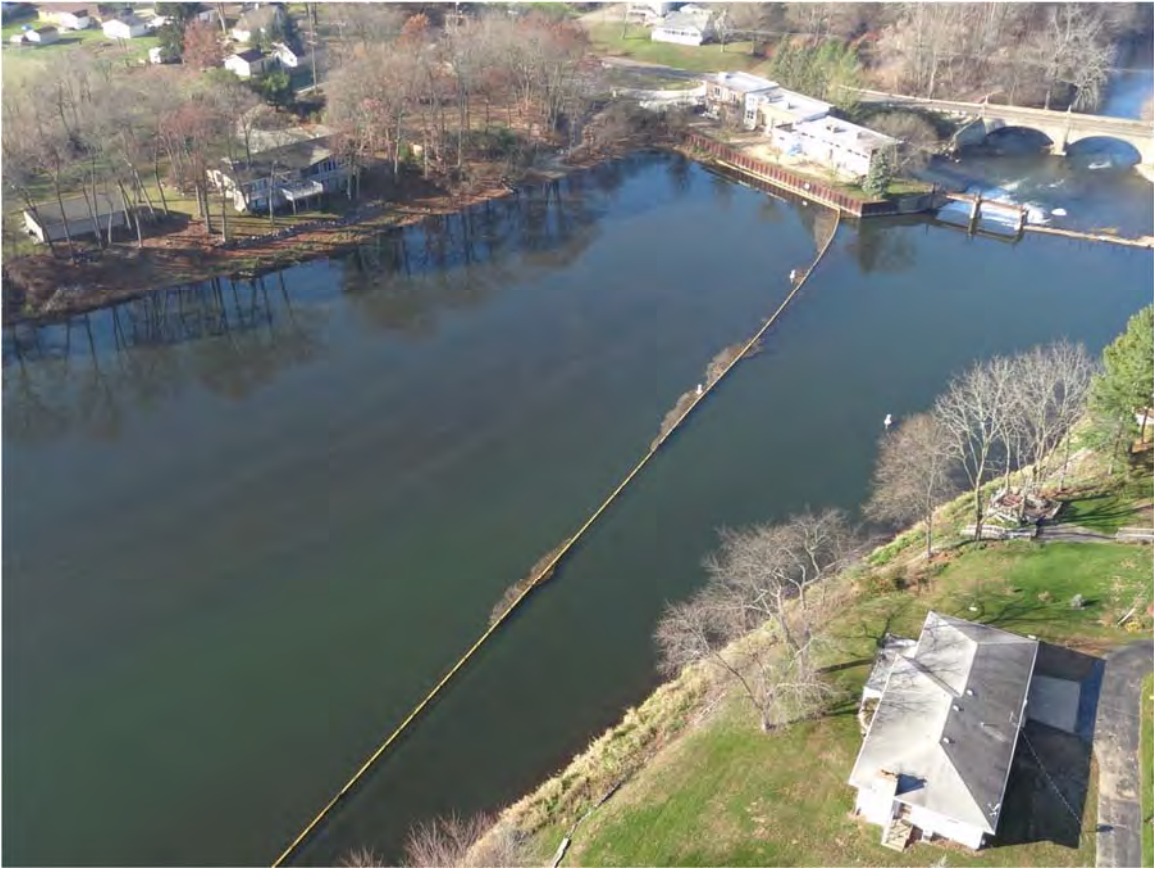
3. Ceresco Dam overview.

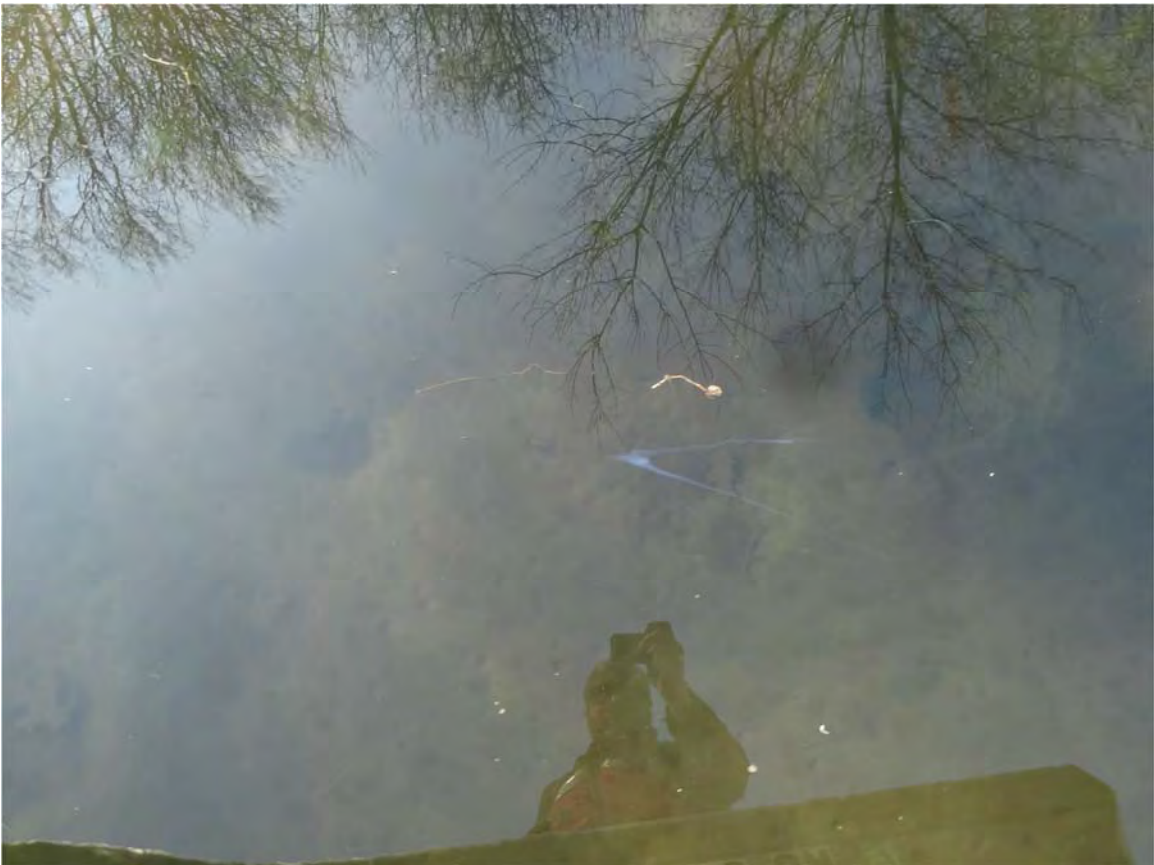
4. MP5.25 LDB observed sheen and tar globs.

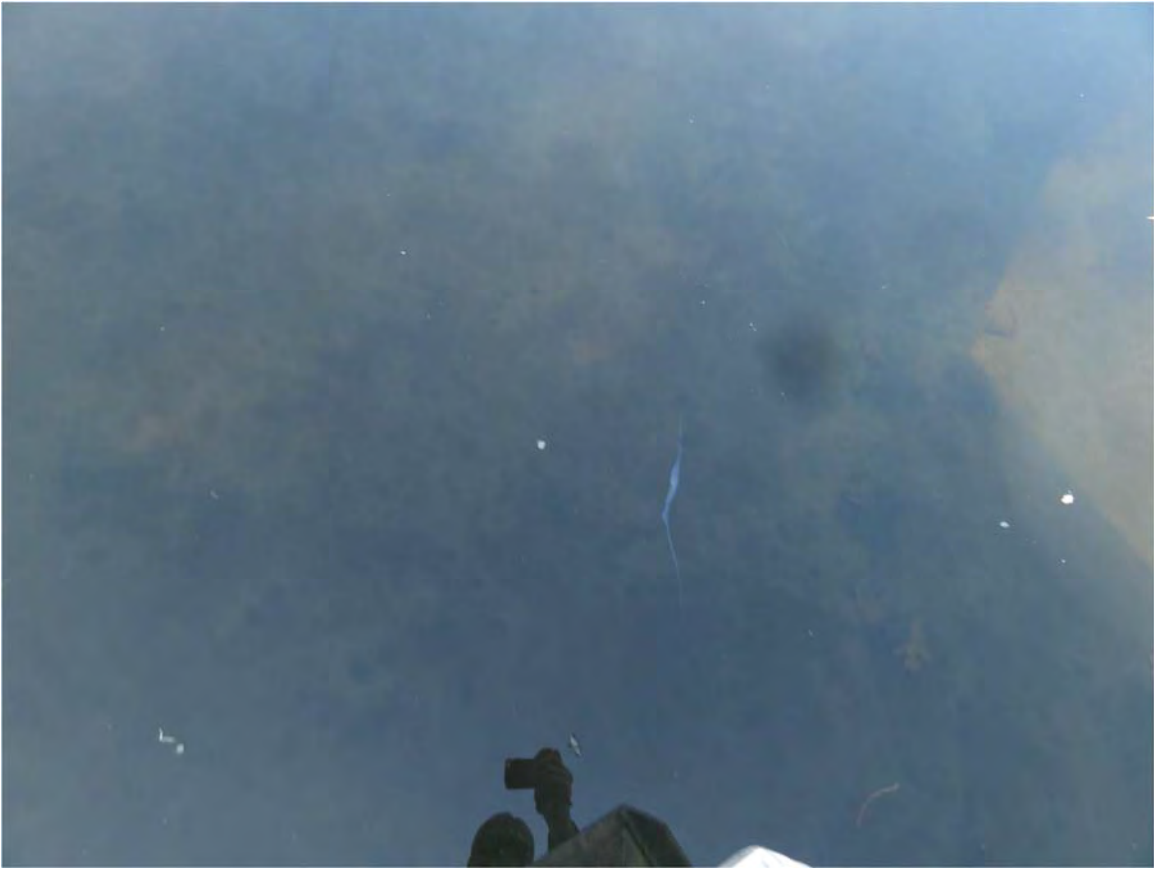
5. MP5.35 LDB observed sheen and tar globs.

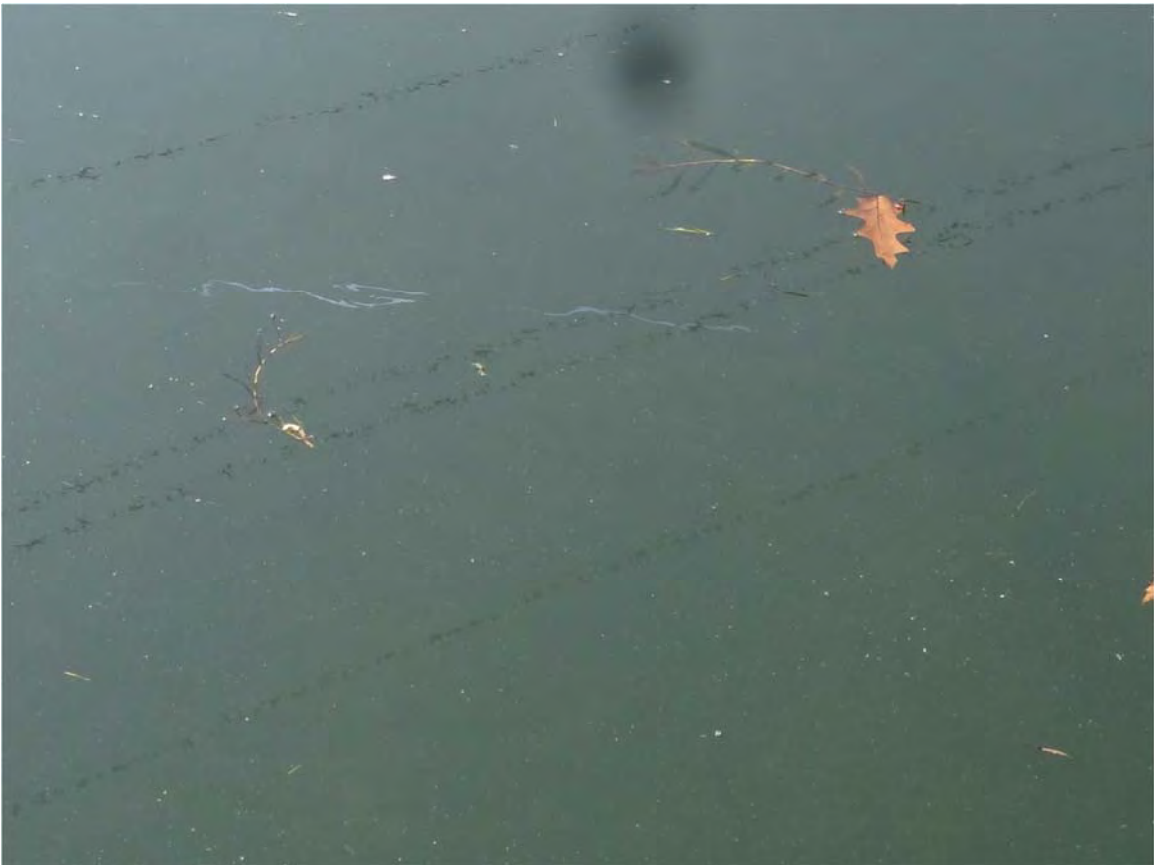
6. MP5.45 LDB observed sheen and tar globs.

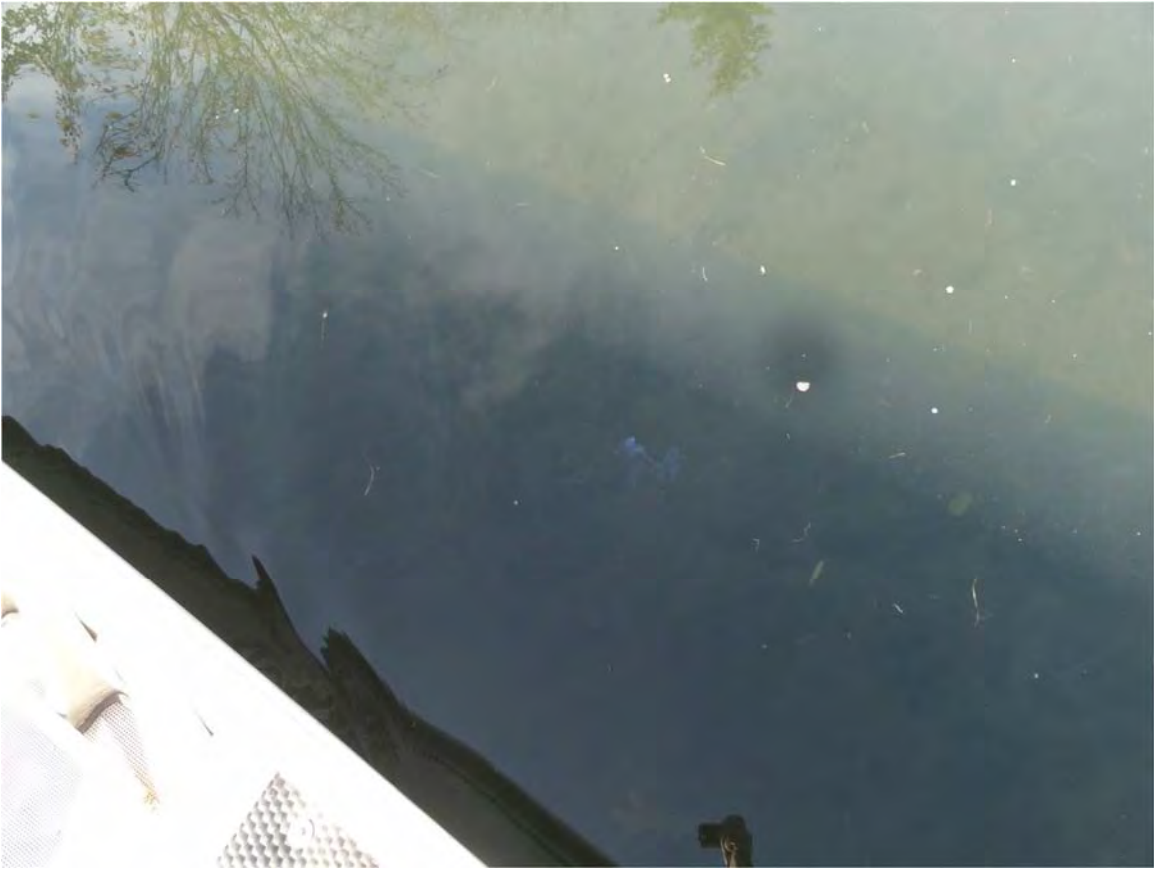
7. Sheen and tar globules observed at Ceresco Dam control point.

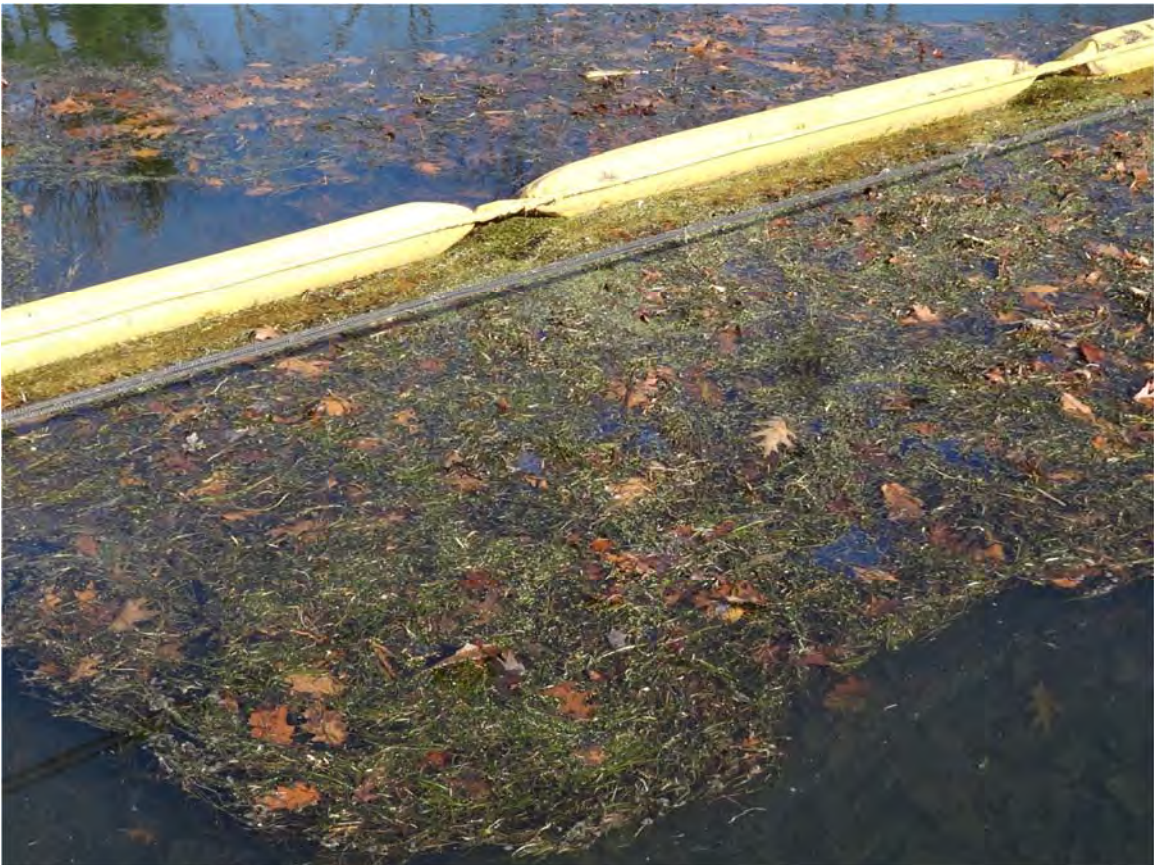
8. Sheen and tar globules observed collecting with the debris at Ceresco Dam control point.

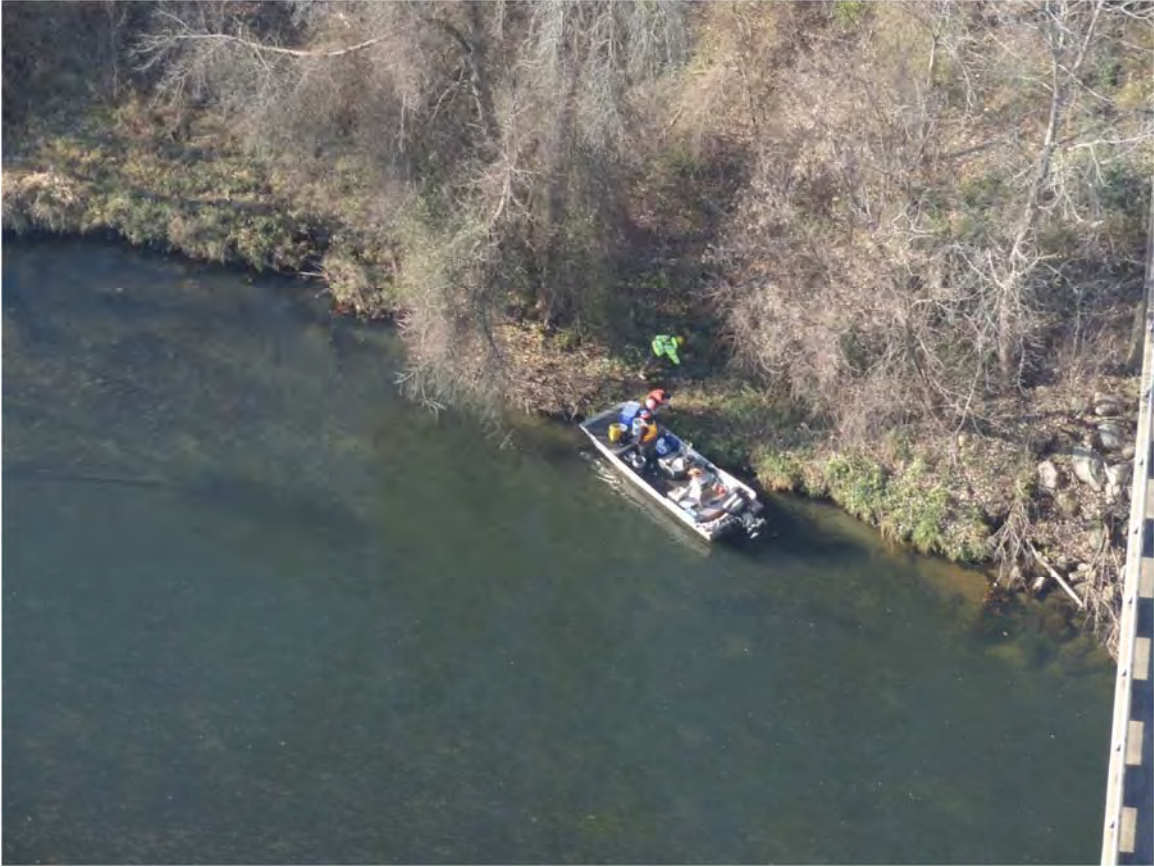
9. MP9.75 LDB observed a RI team.

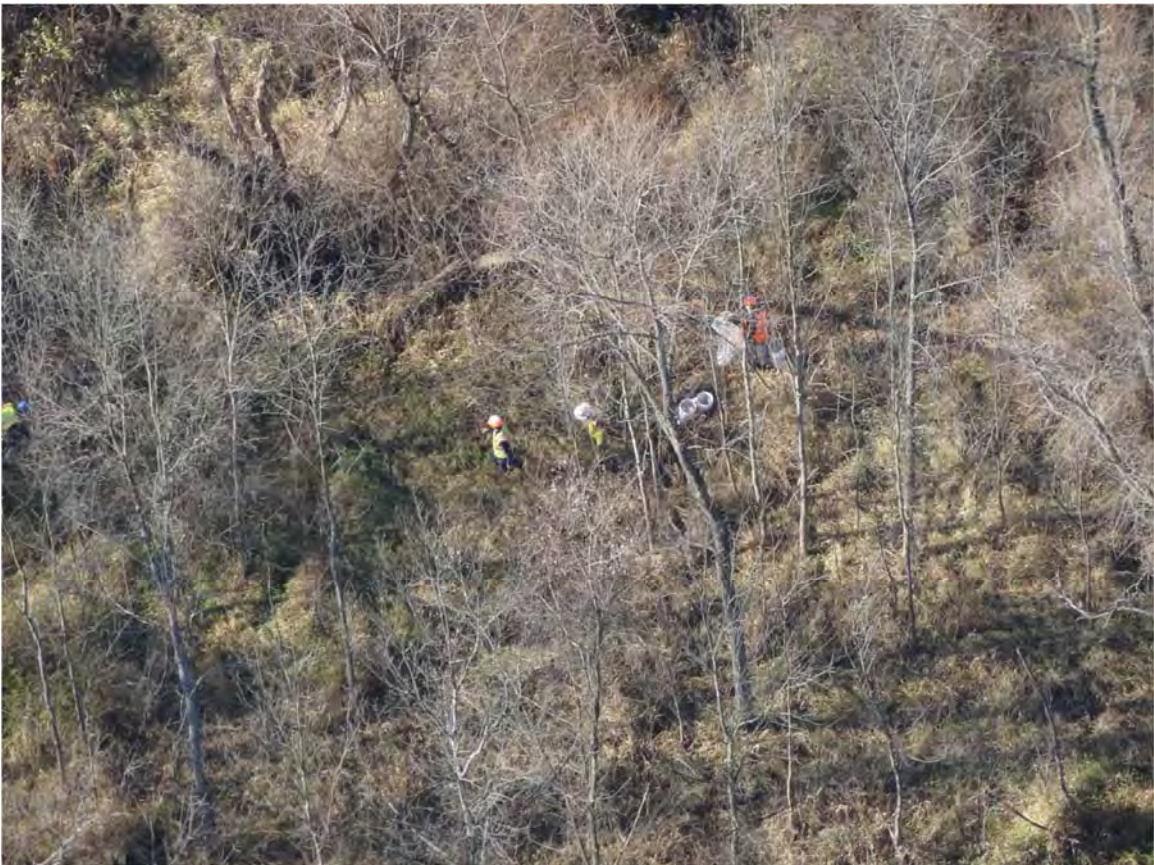
10. MP10.25 RDB observed an RI team.

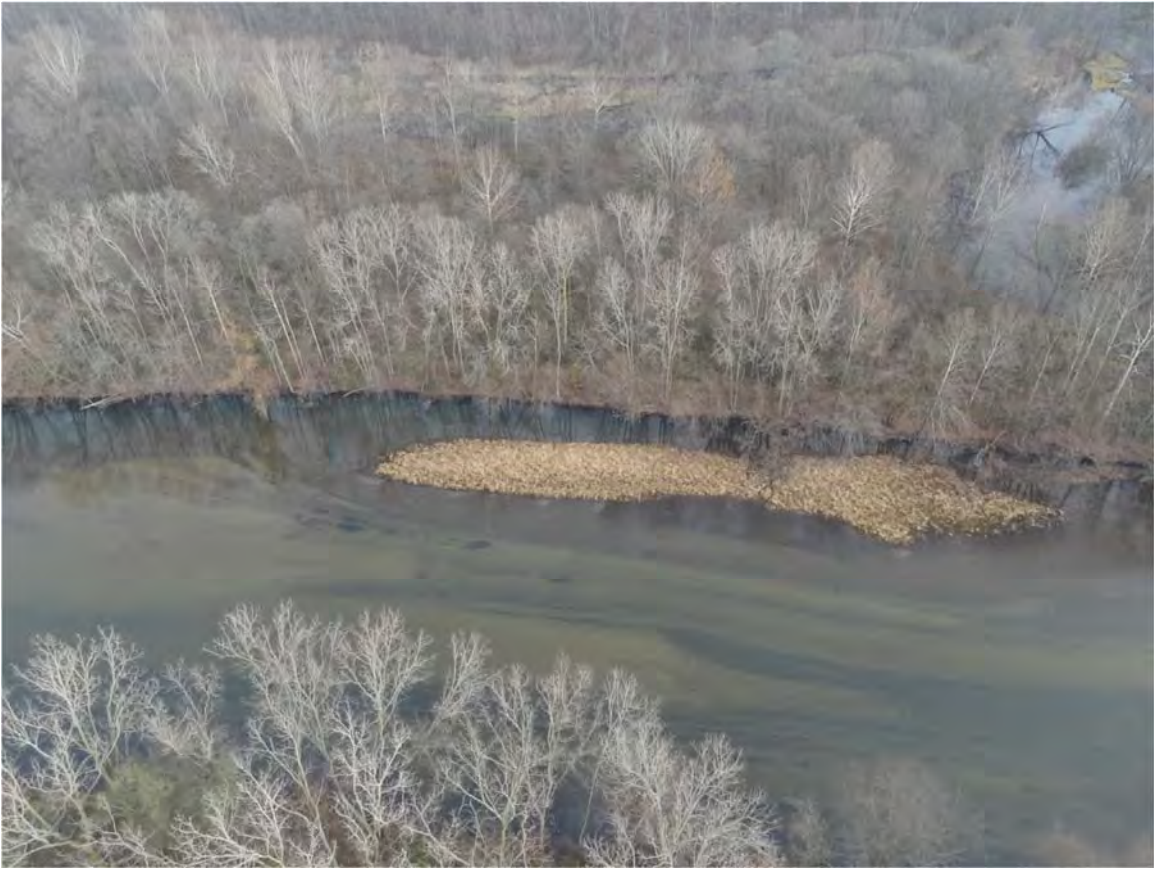
11. MP20.75 RDB sheen observed. The Sheen was checked out by Situation Team 1 and determined to be biological sheen.

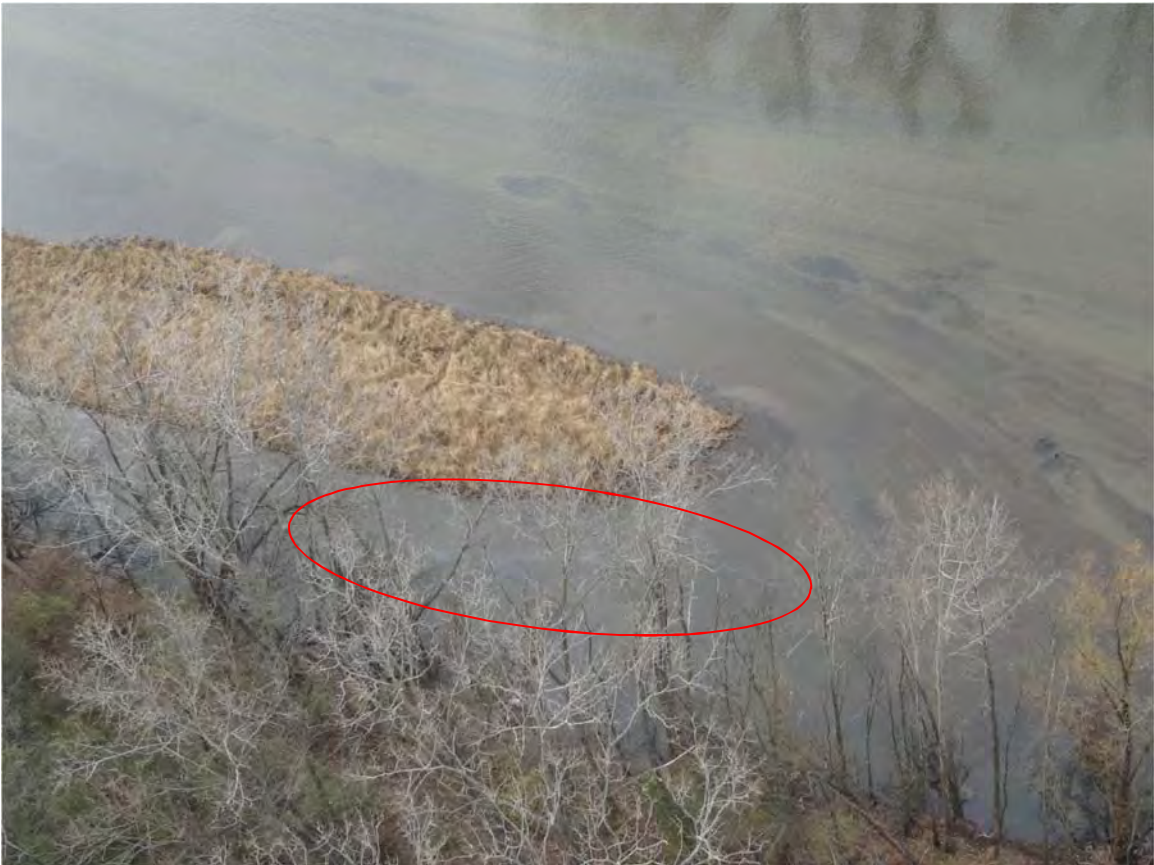
12. MP20.75 RDB sheen observed. The Sheen was checked out by Situation Team 1 and determined to be biological sheen.

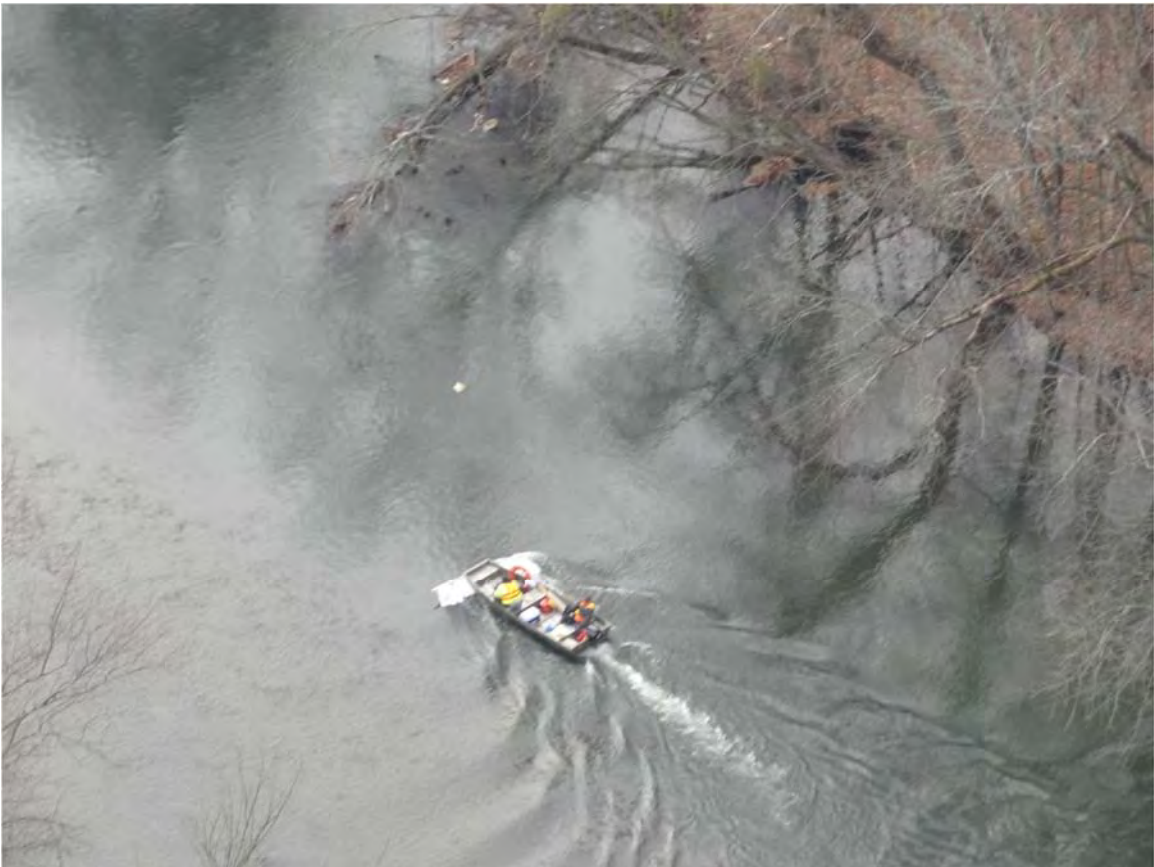
13. Observed a sweep boat mobilizing up to the MP21.5 area.

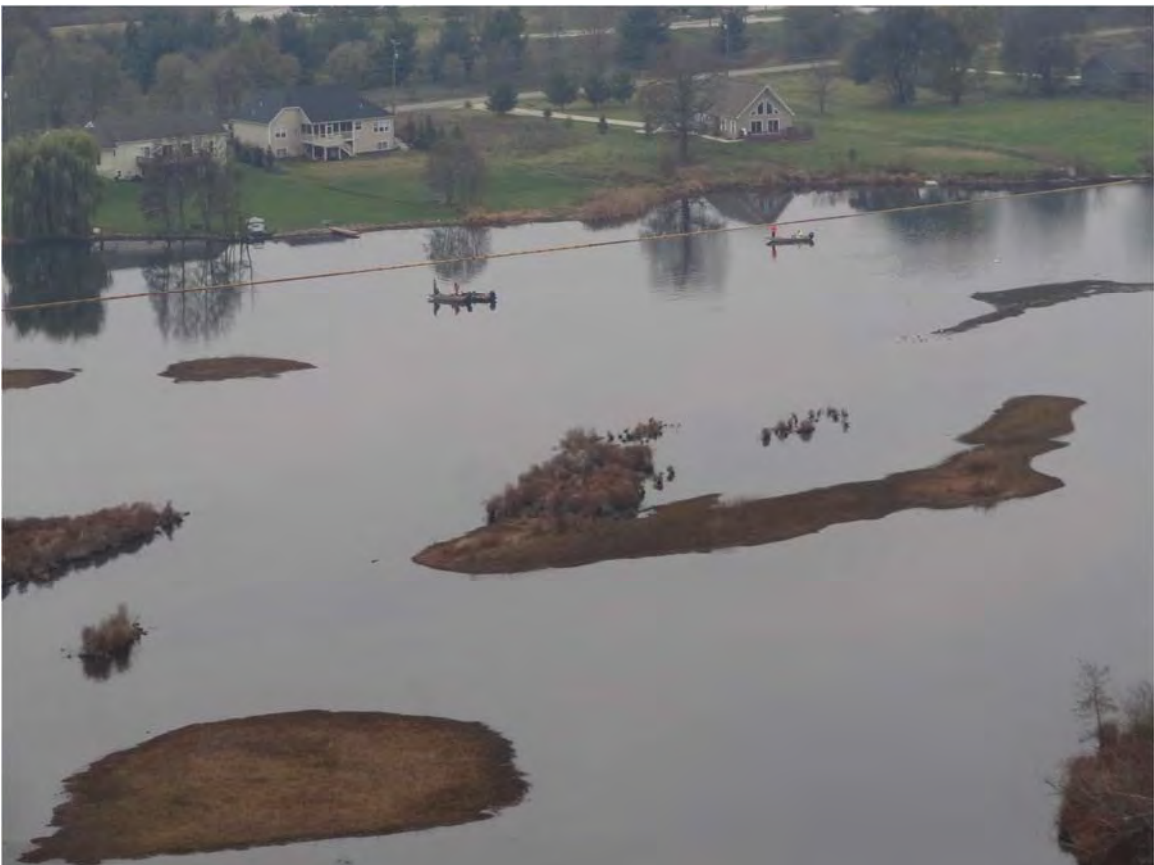
14. Morrow Lake Delta observed a CSD sampling crew.

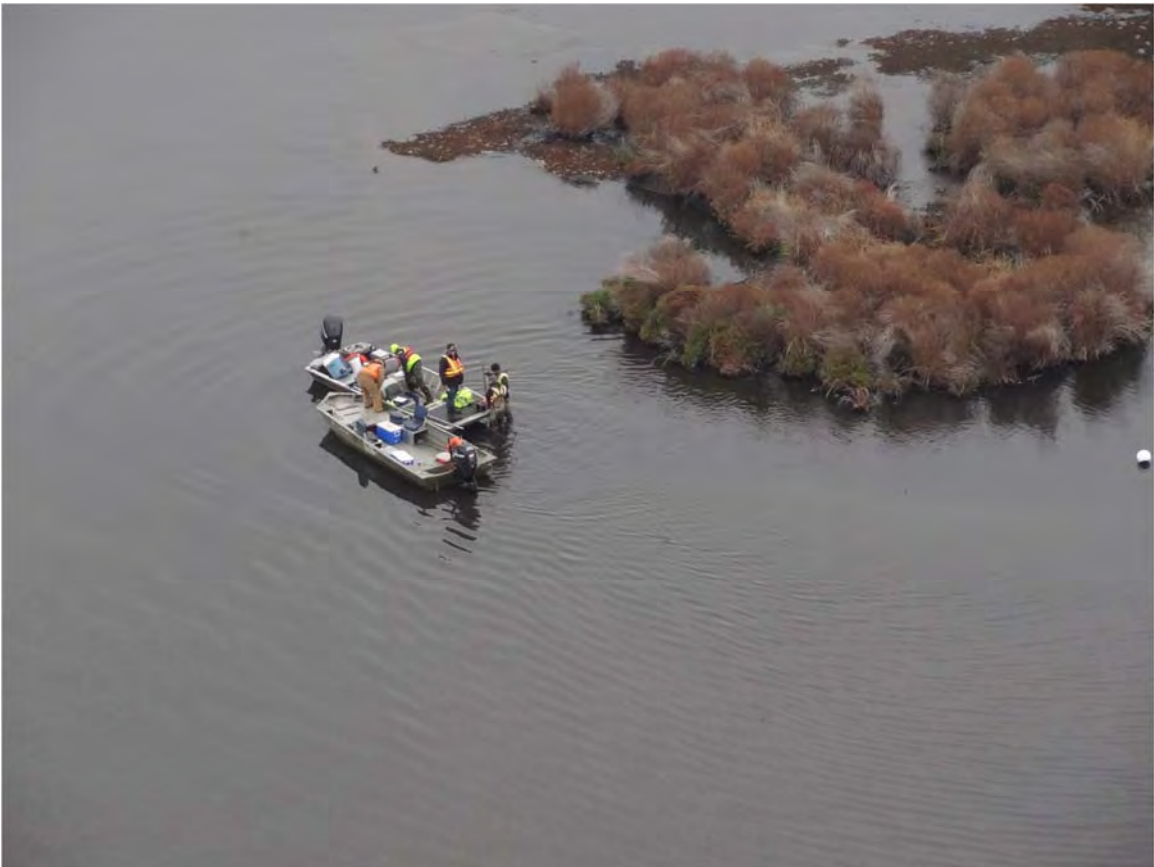
15. Morrow Lake Delta observed a CSD sampling crew.

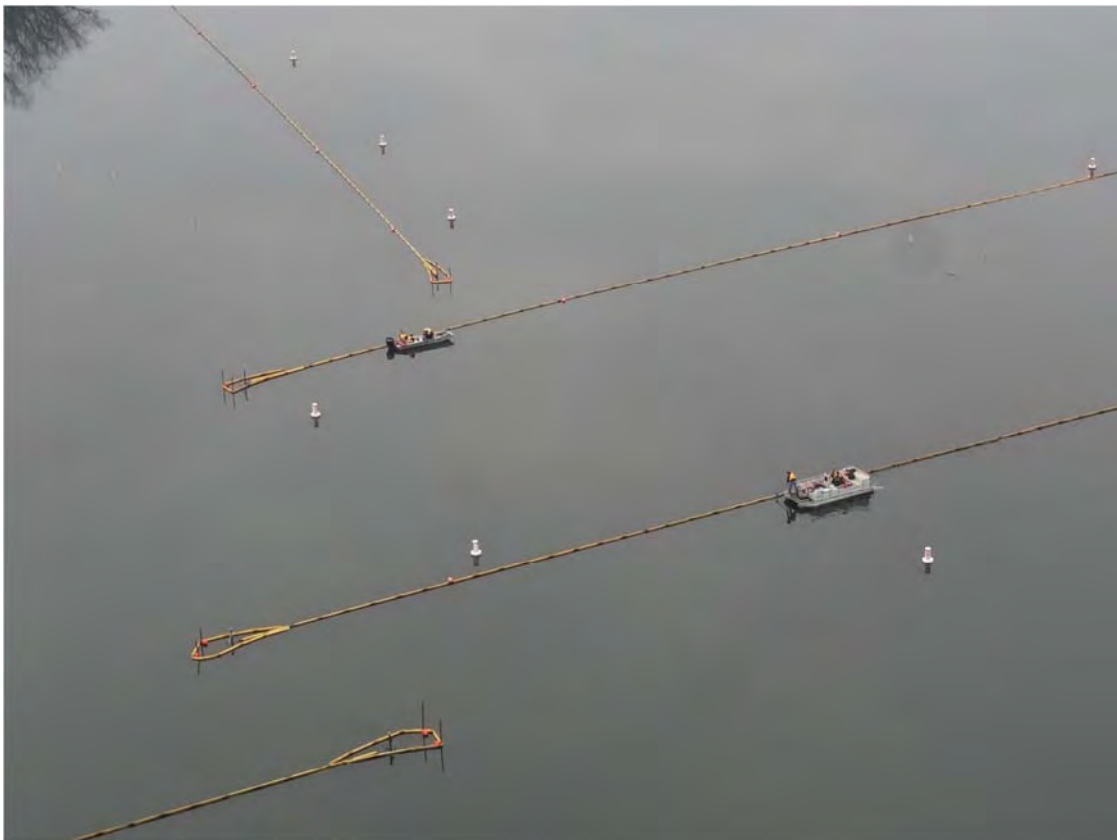
16. Morrow Lake Delta observed crews removing debris and performing curtain inspections.

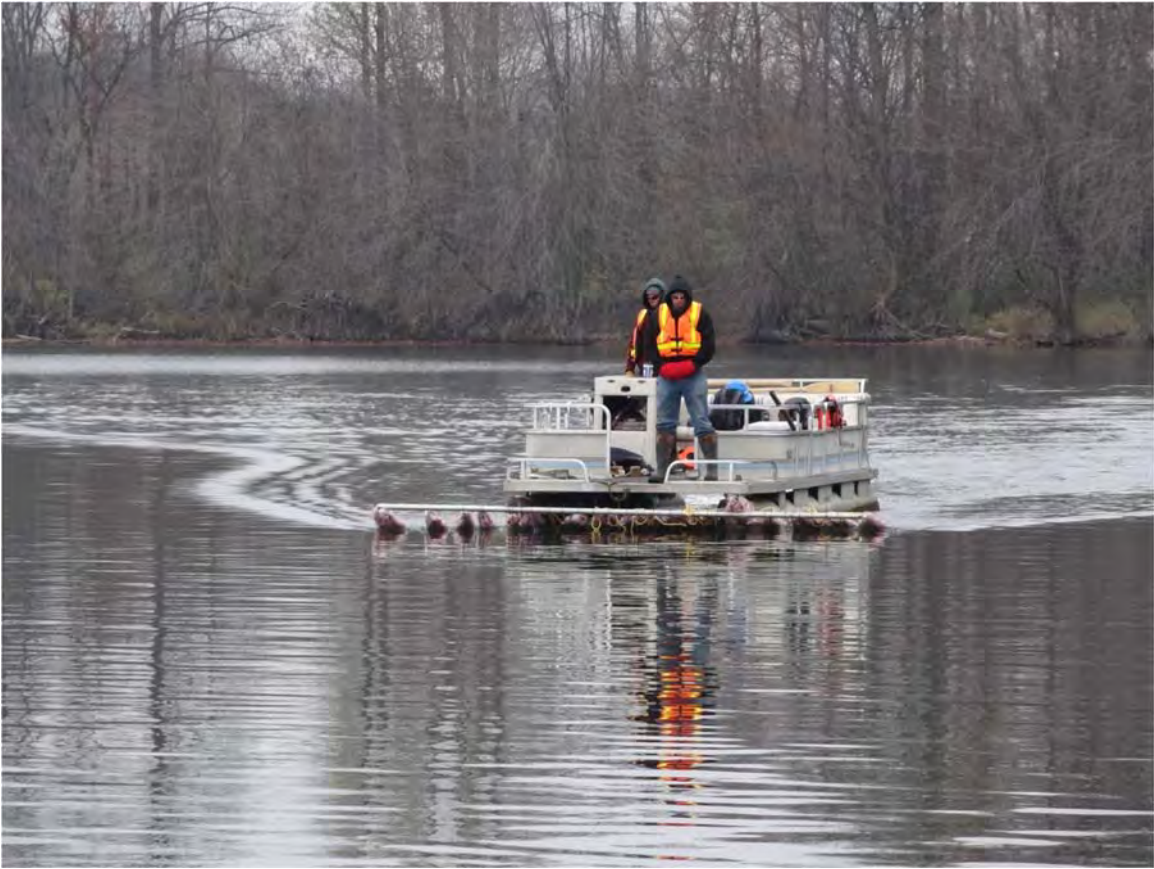
17. Morrow Lake south cove observed a sweep boat operating.

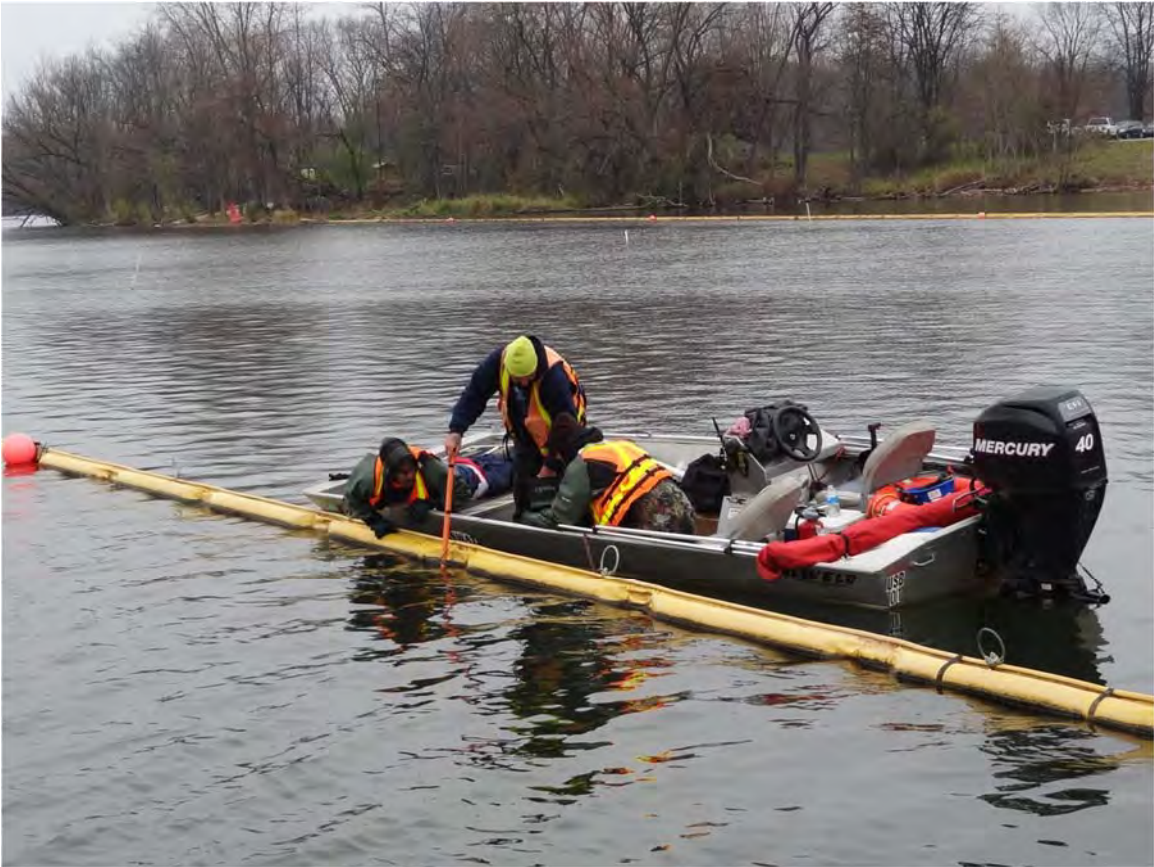
19. Morrow Lake Delta observed a crew inspecting and adjusting the curtain.

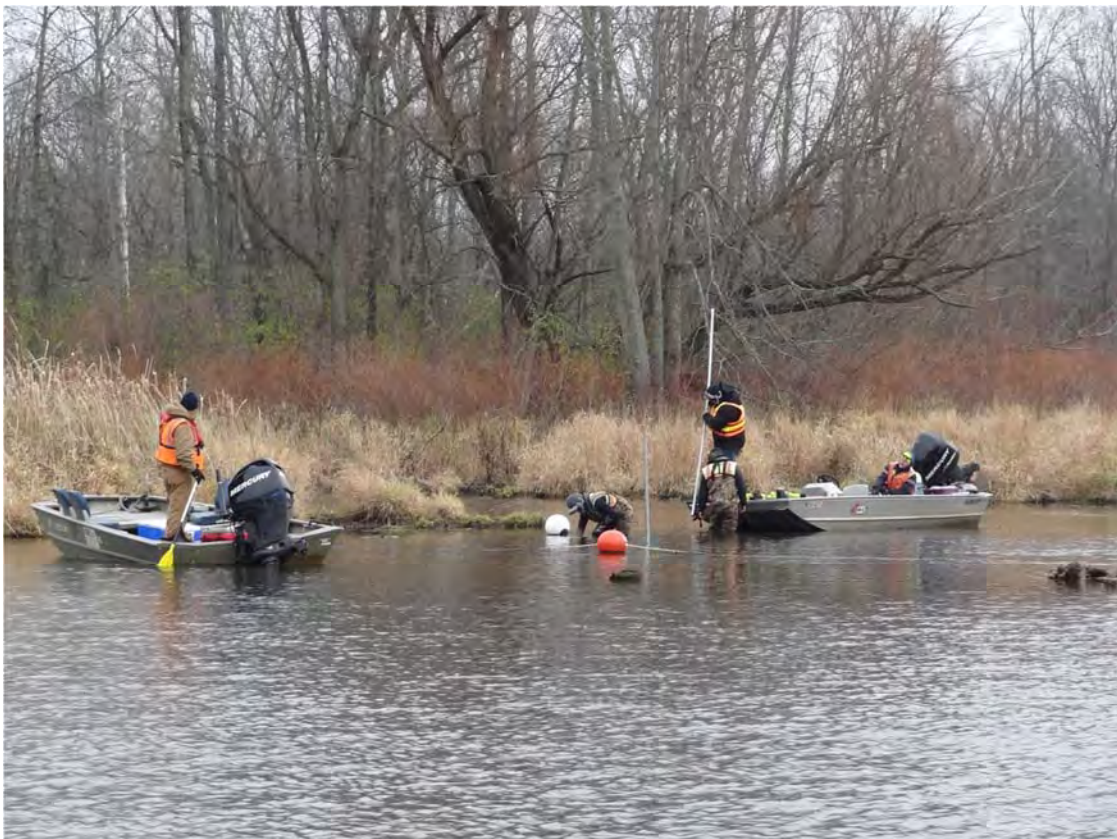
20. Morrow Lake Delta observed crew sampling CSD.

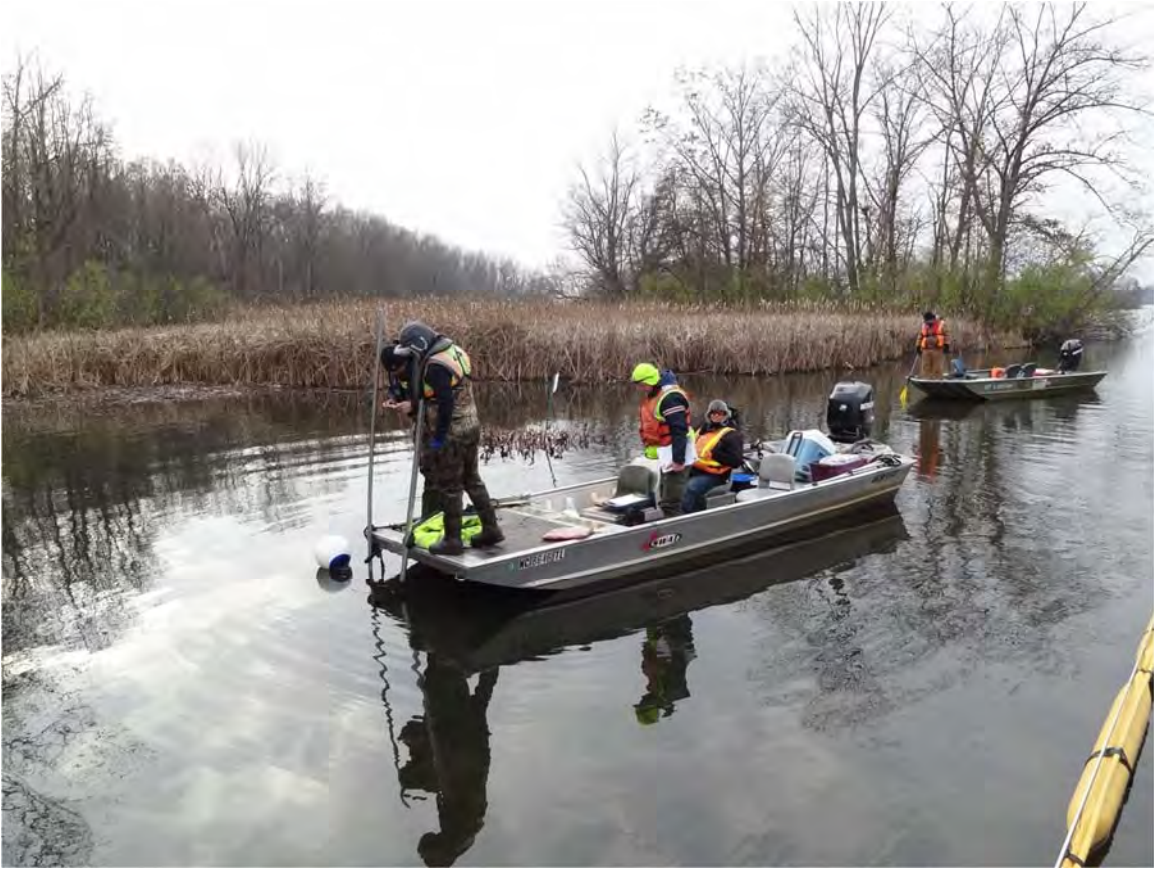
21. Morrow Lake Delta observed a CSD sampling crew.

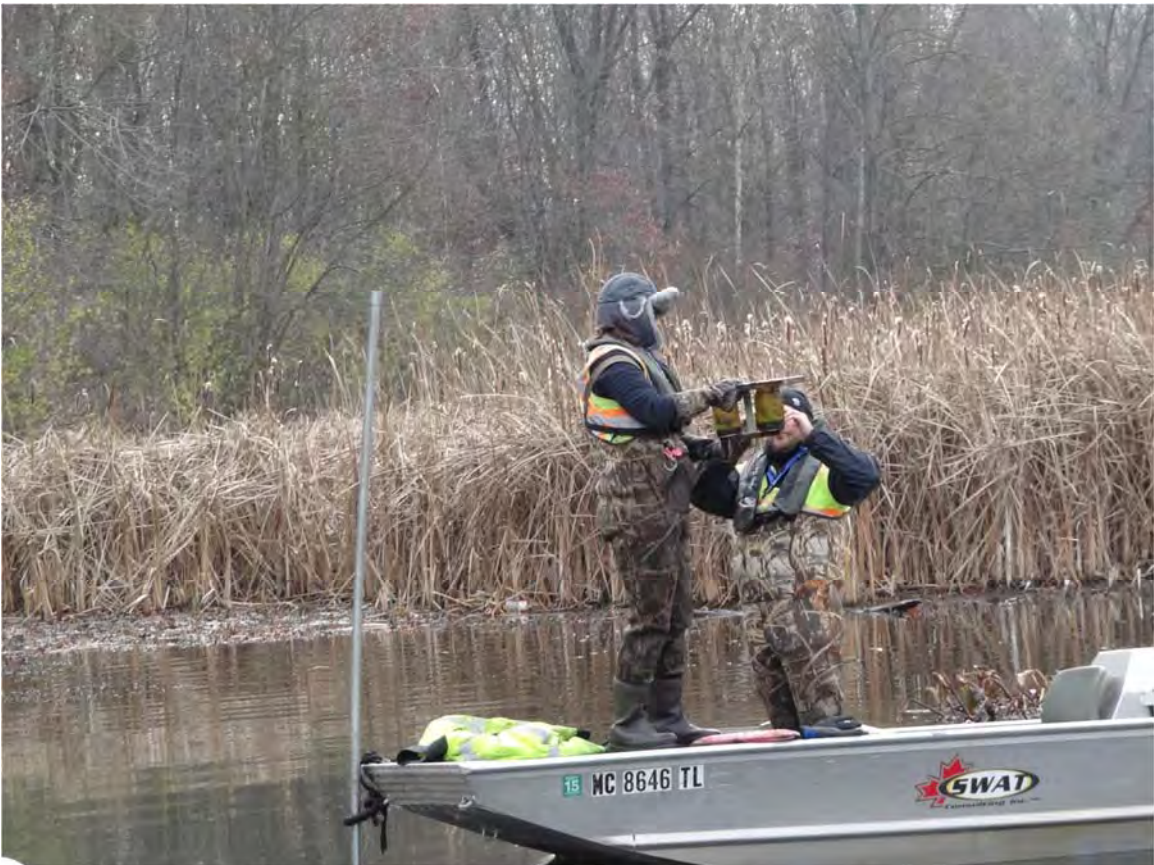
22. Morrow Lake Delta observed a CSD sampling crew.
